WEST HILL POND DAM

CT. 00377

PHASE I INSPECTION REPORT
NATIONAL DAM INSPECTION PROGRAM

JANUARY 1979

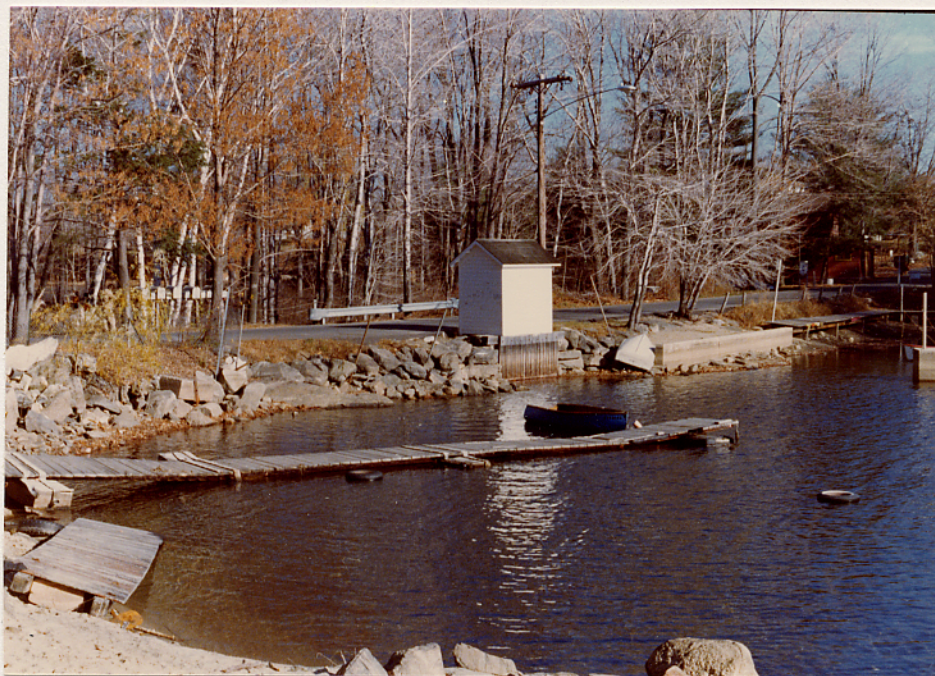
Overview from left abutment

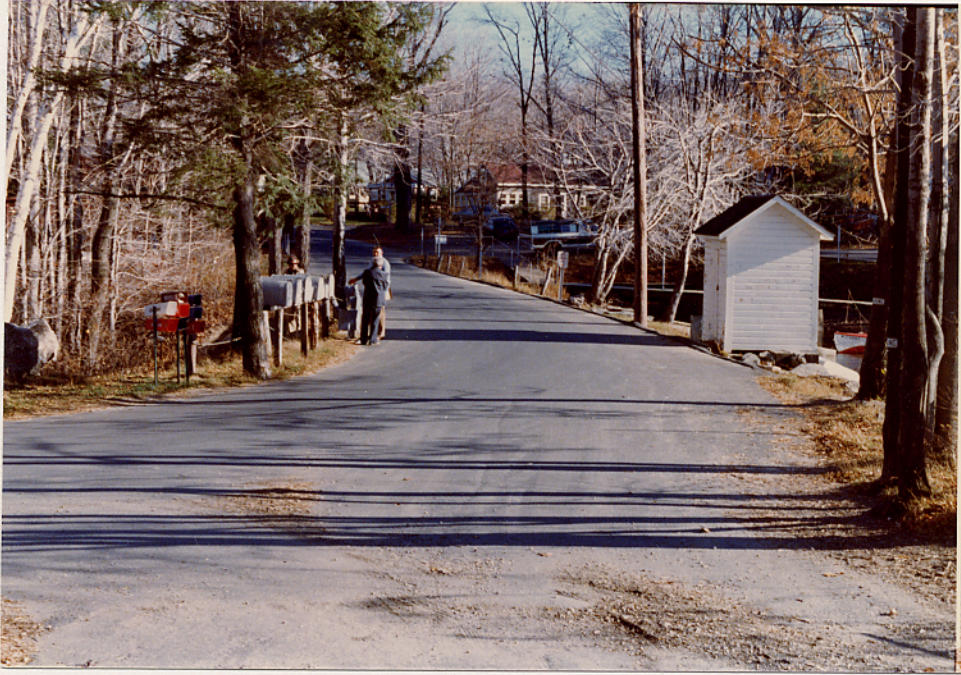
1. Road over dam and gatehouse from left abutment.

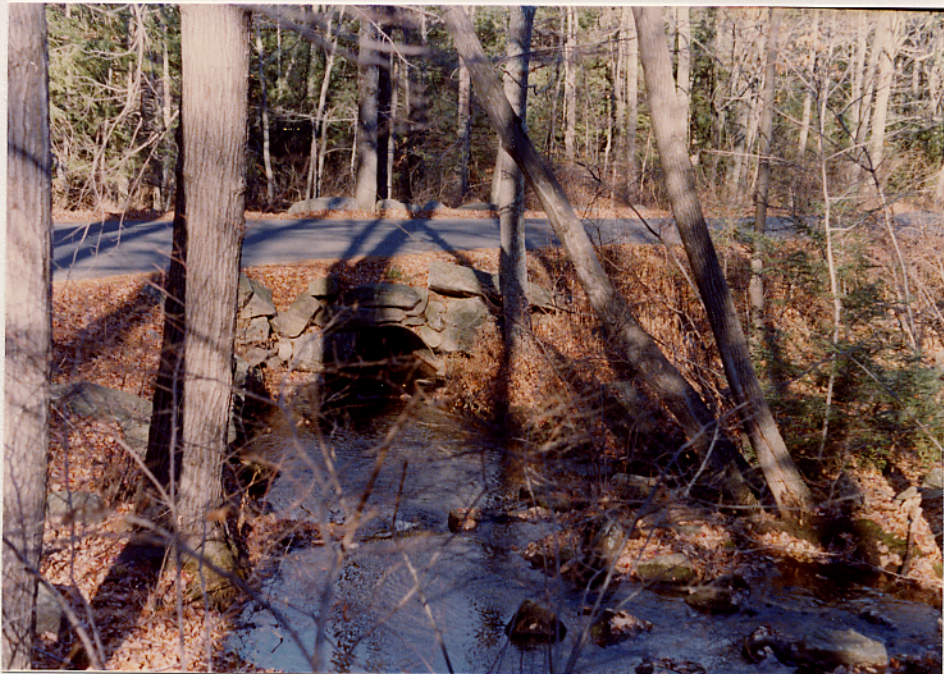
A masonry box culvert 3 ft. wide by 1.5 ft. high placed at natural ground level under the dam leads from the base of the tower to an ashlar masonry gravity headwall at the downstream toe of the dam. The headwall is in fair condition, but some incipient raveling is becoming evident (Appendix C, Photo No. 3). The invert of this culvert is about 10.5 ft. below the crest of the dam. The culvert discharges directly into the downstream Morgan Brook channel, which at the time of the inspection was filled with rocks and stones so as to almost submerge the downstream exit of the culvert (Appendix C, Photo Nos. 3 & 4). The length of the culvert measured from the tower to the downstream outlet is about 30 ft. About 300 ft. below the dam, Morgan Brook is carried under a local road via a 36 in. dia. pipe (Appendix C, Photo No. 2).

2. Pipe culvert under local road about 300 ft. downstream from dam.

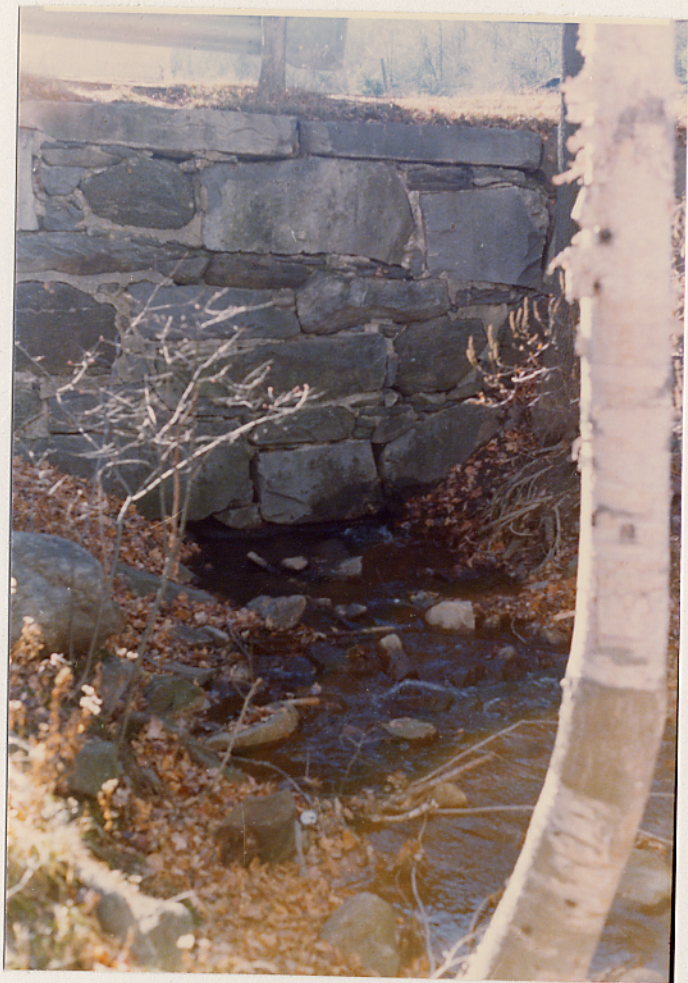
Ashlar masonry in fair condition with masonry
headwall.

3. Outlet of masonry culvert under dam.

1. Determine whether additional spillway capacity is required.
2. Determine whether the existing outlet gate is of adequate size and in good repair.
3. Provide a means for removal of floating debris which is less subject to clogging and does not restrict spillway discharges.
4. Determine whether the masonry outlet culvert under the dam is of adequate size, unobstructed and in good repair.
5. Determine whether the outlet culvert headwall requires repair.

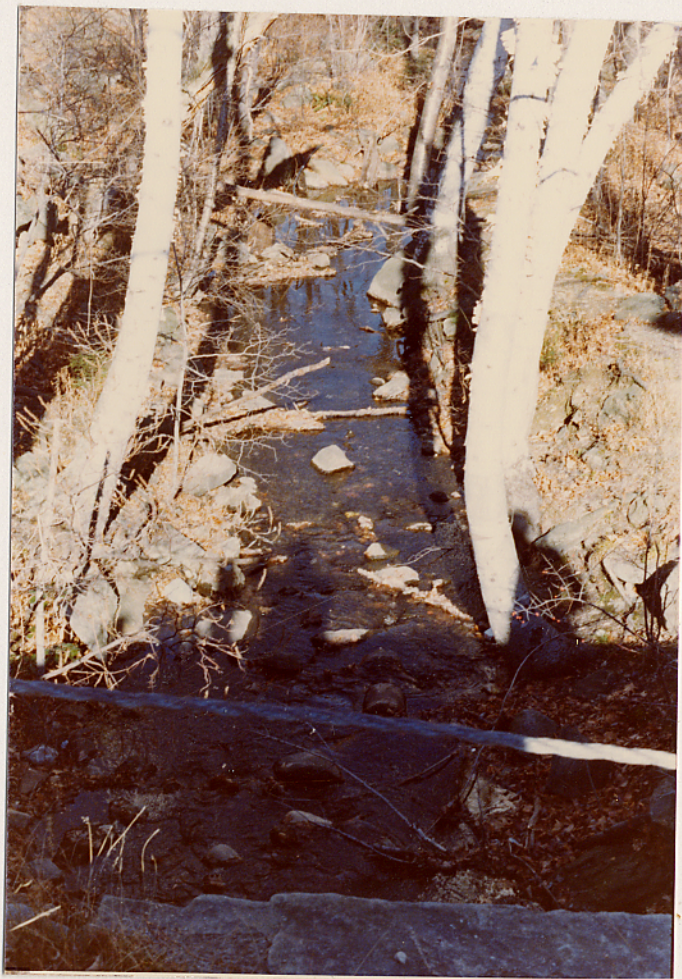
Heavy growth has invaded the rather poorly defined downstream channel, which is to some extent also obstructed by random boulders immediately below the dam. Conditions along the Morgan Brook and Mallory Brook are discussed in Section 1.2d.

4. Morgan Brook immediately downstream from culvert headwall.
